Urbana Residential Phase 1 Inspection Report

Inspection Date : 28th June

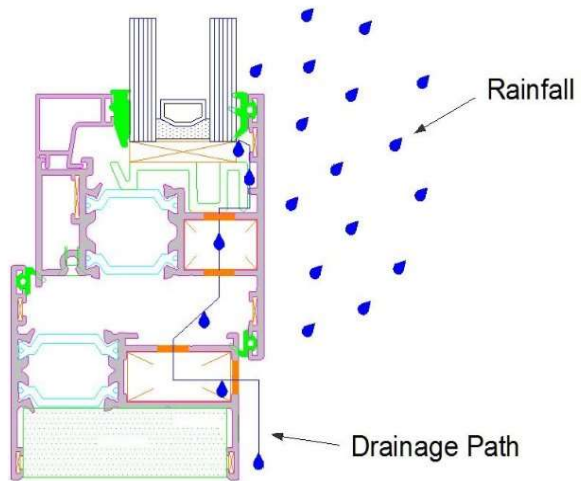
CASEMENT WINDOW

IDEAL DRAINAGE CONDITIONS

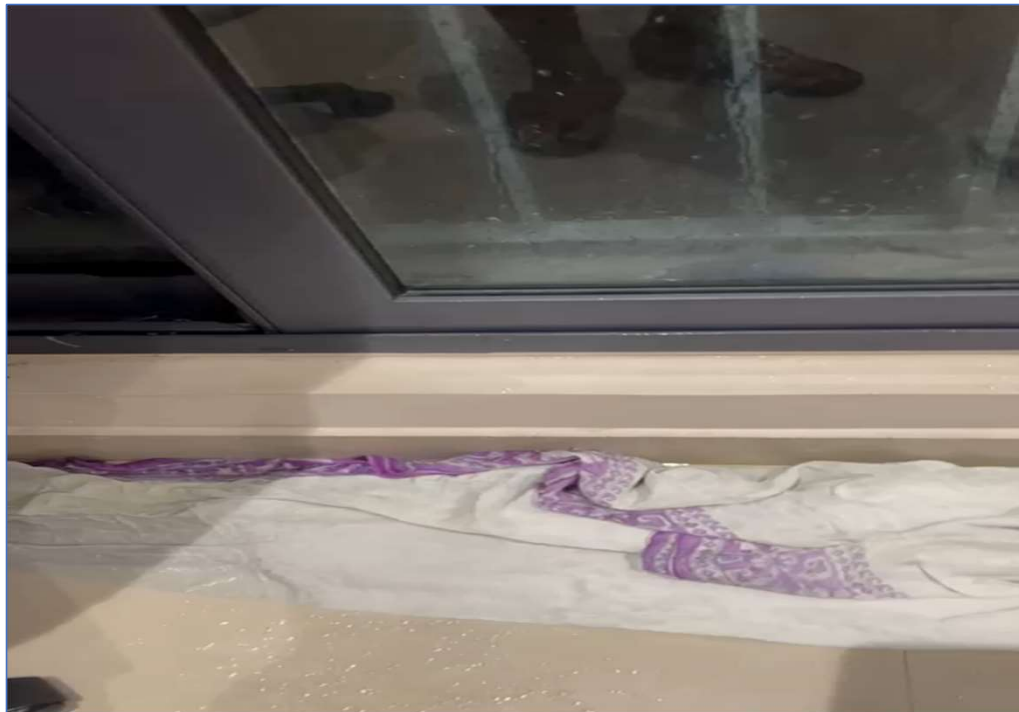
- Majority of the cases due to rainwater entering through the sliding windows are not leakage but water spillage due to bubble effect created due to pressure difference. This effect happens occasionally due to difference of Temperature and wind turbulations. During certain days of year due to wind and temp difference the pressure outside the building is marginally more than the indoor pressure .
- Periodical servicing and maintenance deficiency.
- However, observed some wear and tear on certain windows, particularly those that had been exposed to harsh weather conditions over the years. This natural weathering had likely contributed to the minor issues experienced during the heavy rain.
- Improper alignment of window shutters due to operational deficiency.

EVIDENCE OF SEEPAGE THROUGH SLIDING WINDOW

- Additional drainage points to be created in fixed windows along with fixing of NRV valves.
- Additional drain caps to be installed.
- Incorporate 'End Dam' to increase water retaining capacity, where it is missing.
- Periodical servicing of the windows required like shutters, locks etc., so that alignment is proper.
- Proper and timely cleaning of window channels.
